Upper Fox River Streambank Erosion and Pollutant Load Characterization

March 22, 2019
7th Annual Fox River Summit
Burlington, Wisconsin

SEWRPC

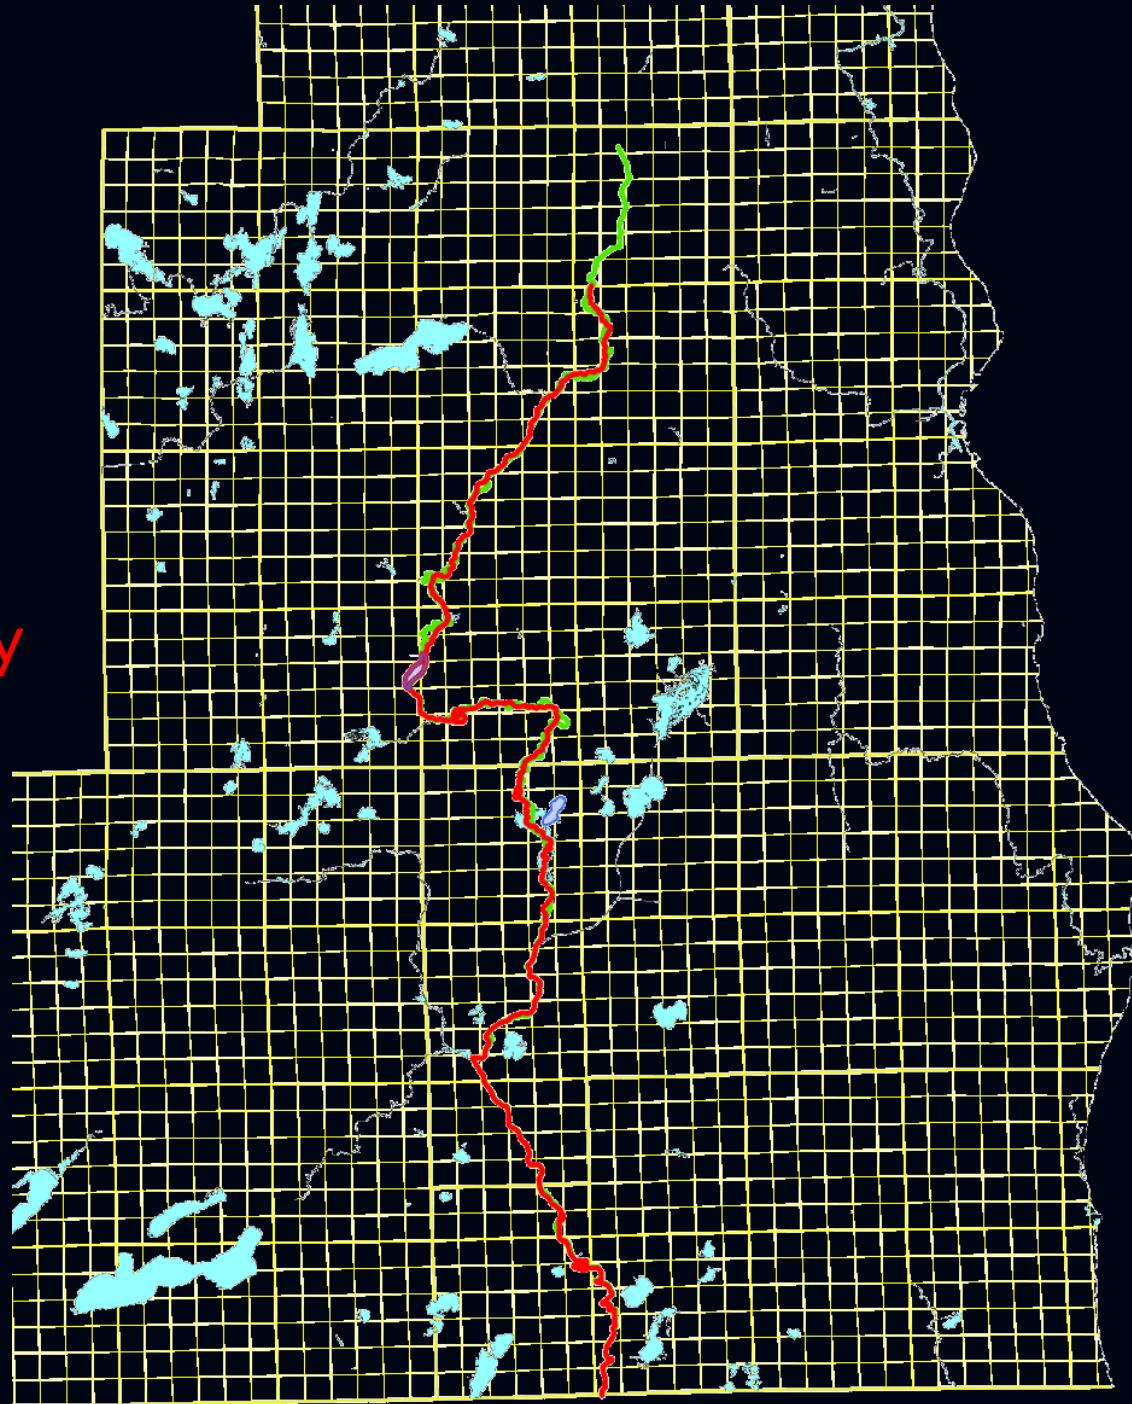
Post-Settlement Channel Evolution

1836 River Channel
On-the-ground survey

2015 River Channel
Orthophotography

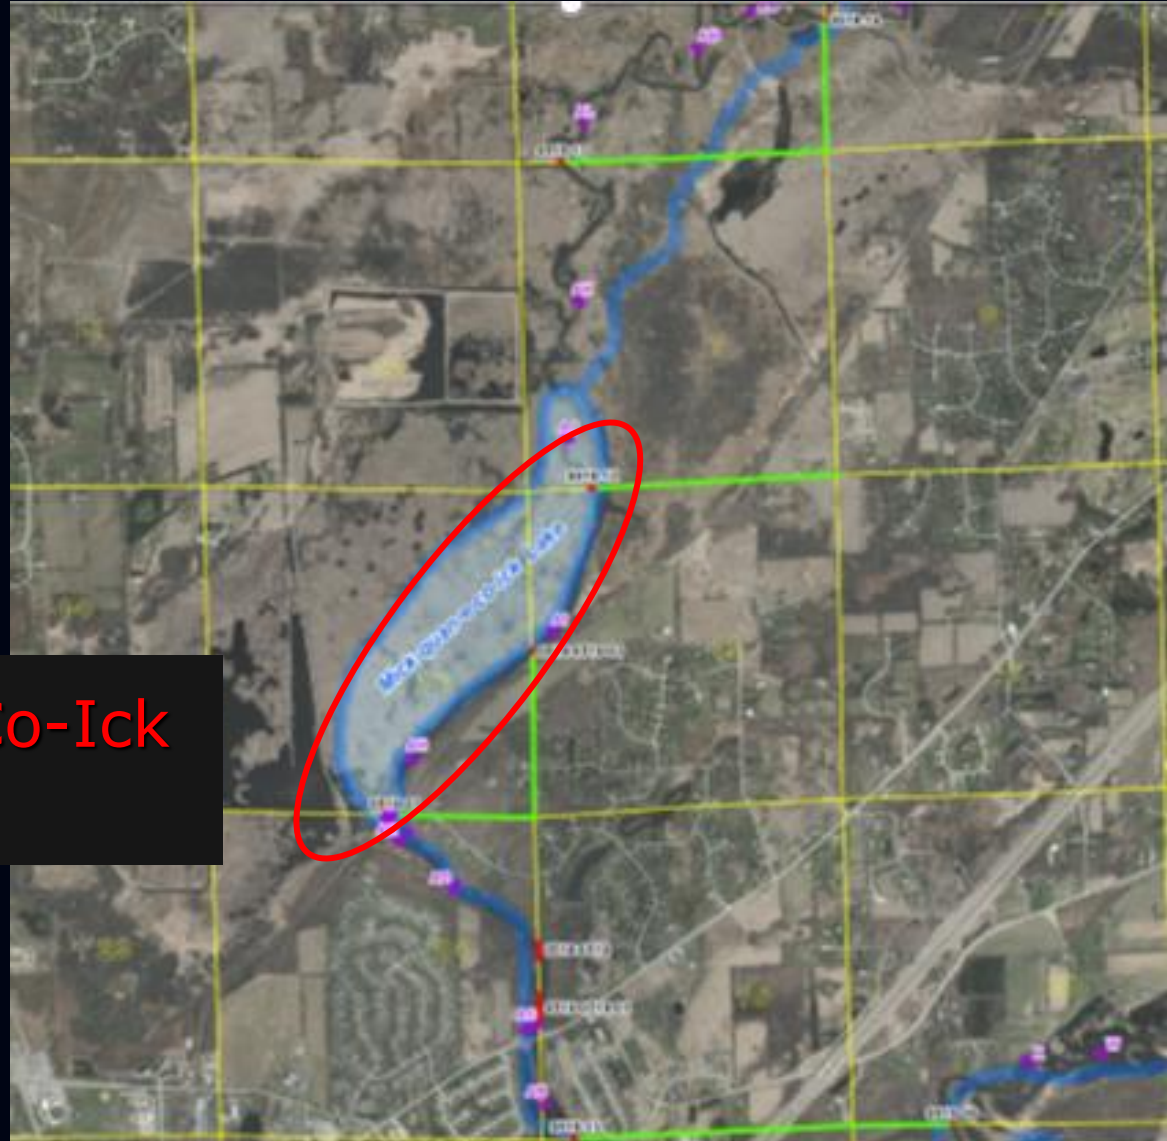
1836

Post-Settlement Channel Evolution

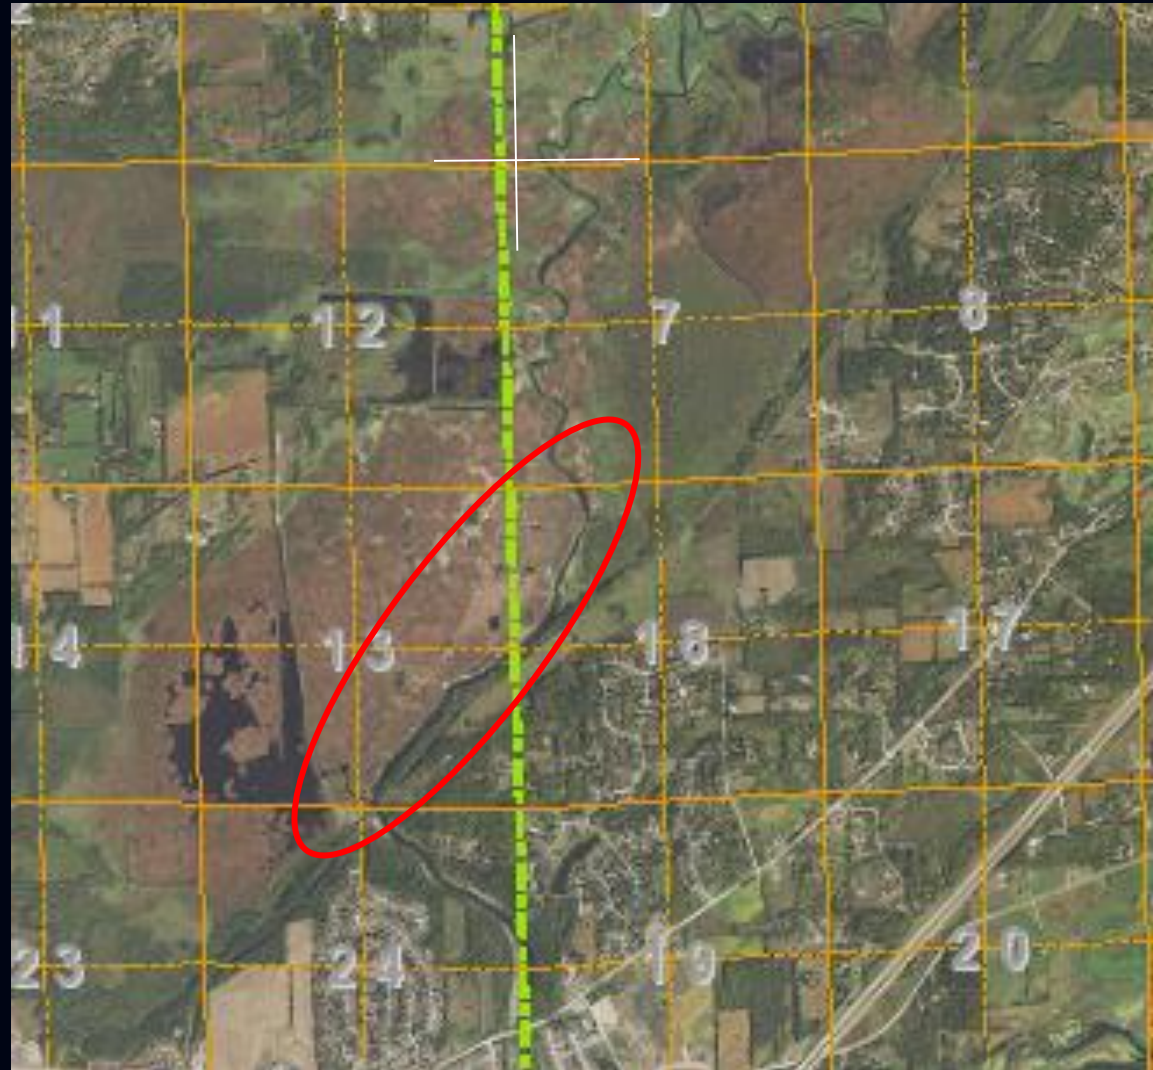
2017

Post-Settlement Channel Evolution

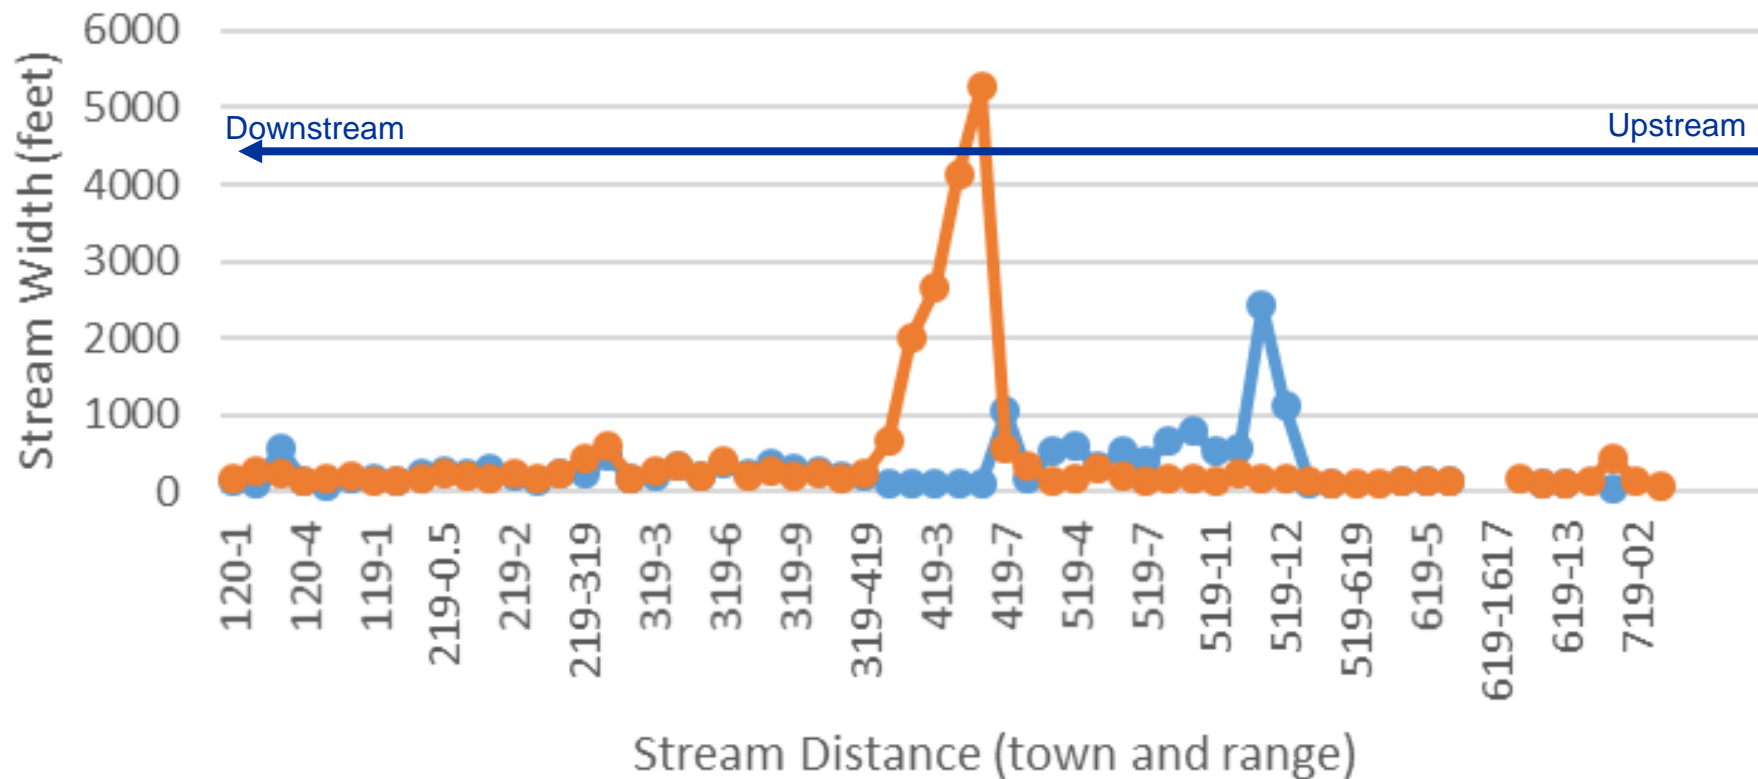
Fox River Width Comparison

● 1836 Stream Width (feet)

● 2015 Existing Stream Width (feet)

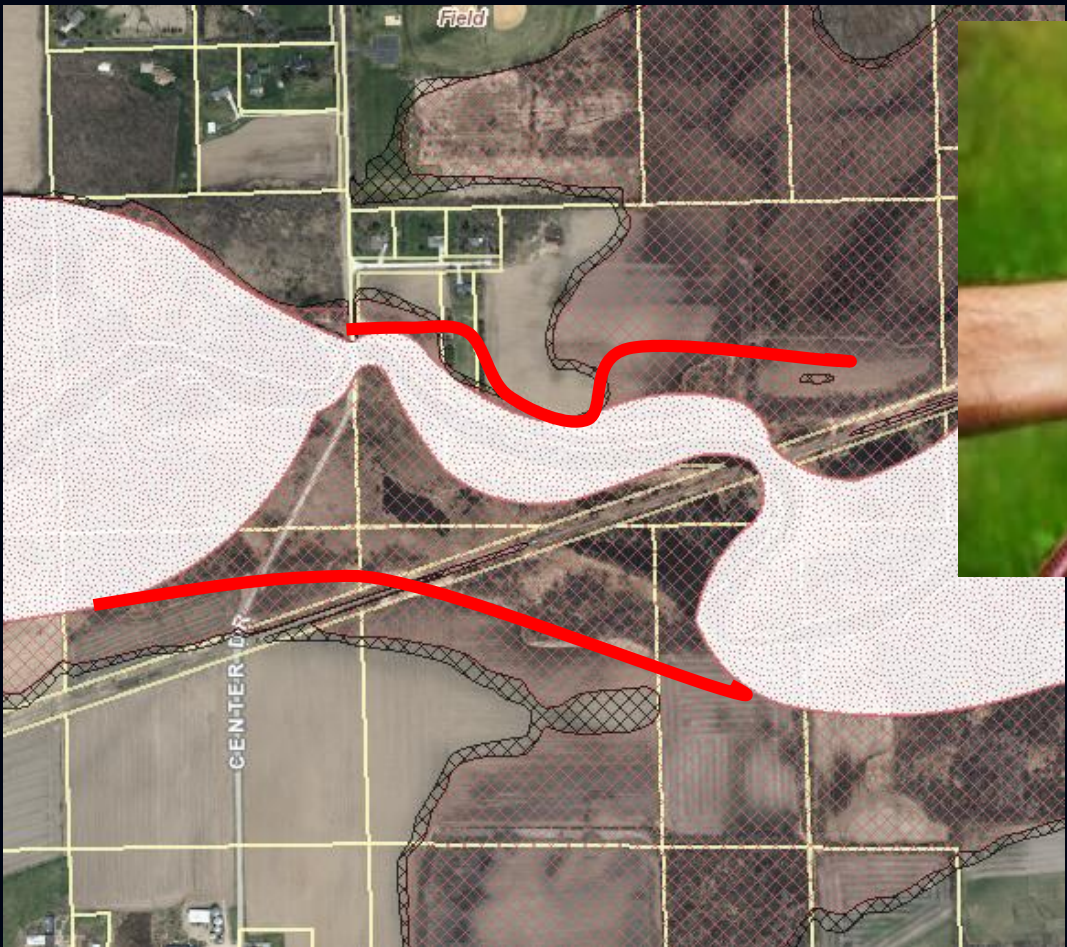
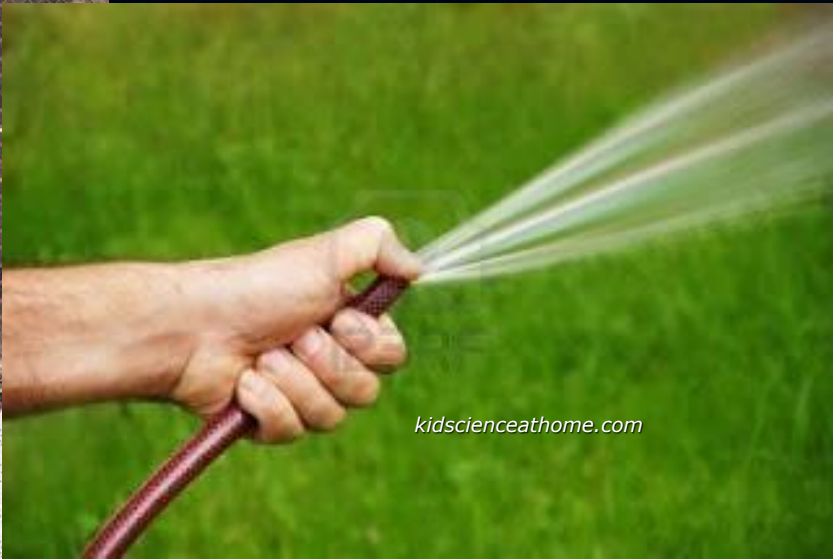
Confining stream channel increases stream power and promotes bed/bank erosion.

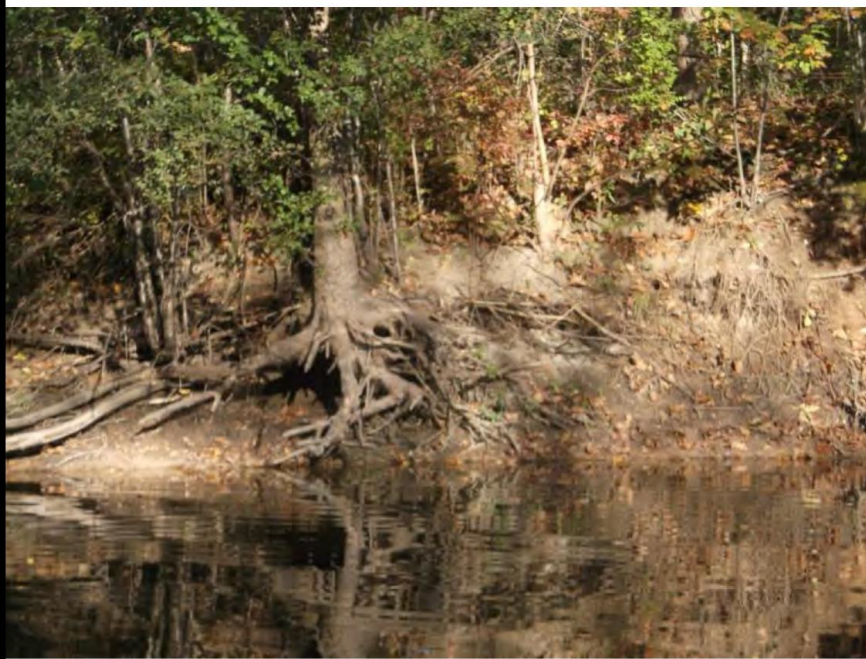
Photo #: 56

Location ID: 111

Significant bank erosion.

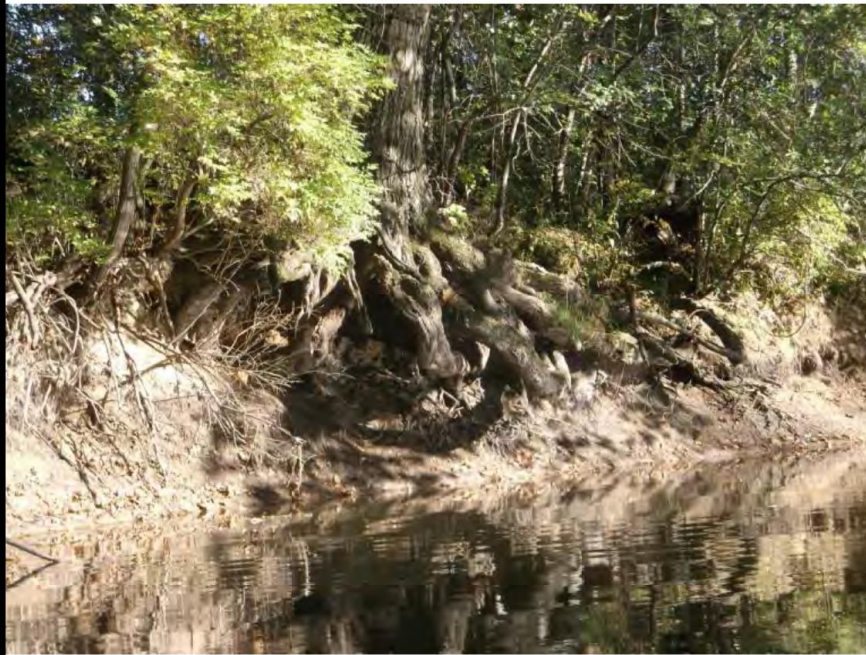
Photo #: 57

Location ID: 111 Bank erosion.

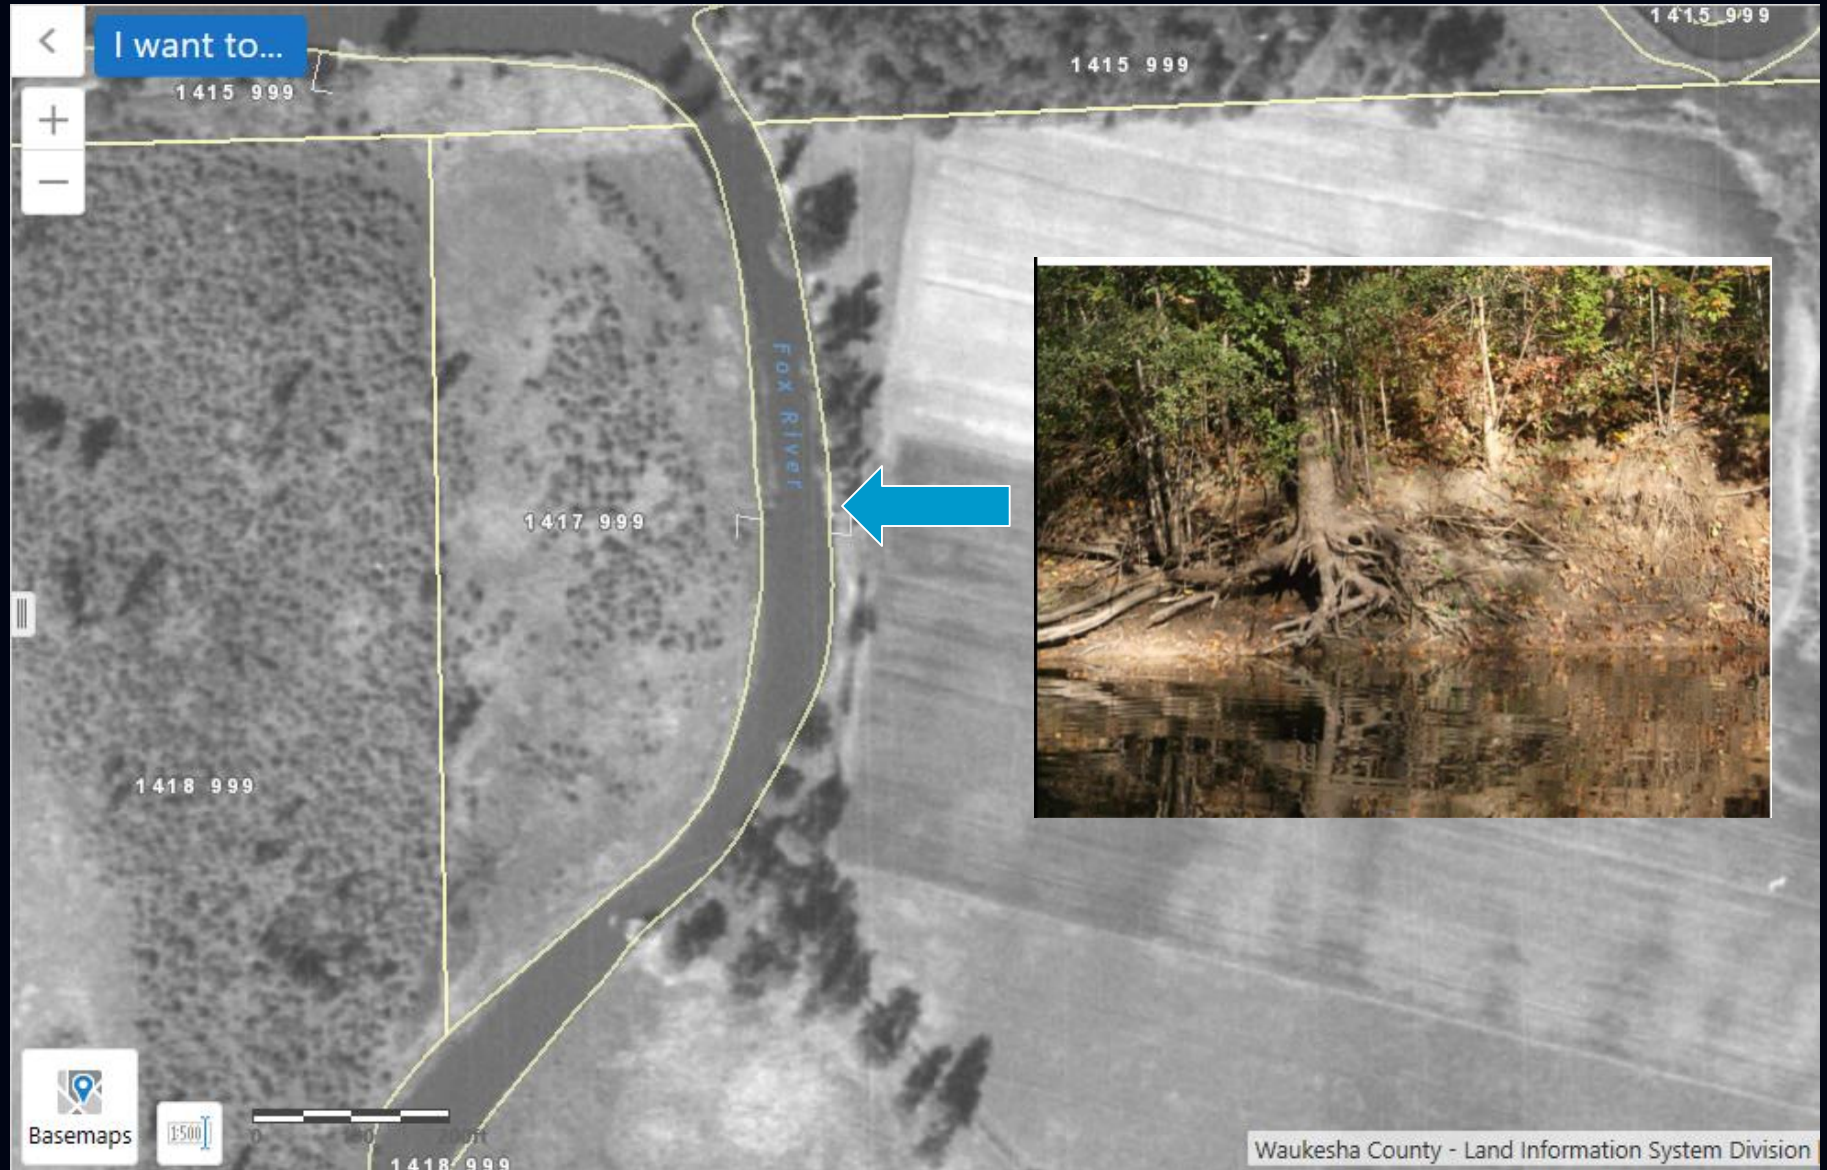
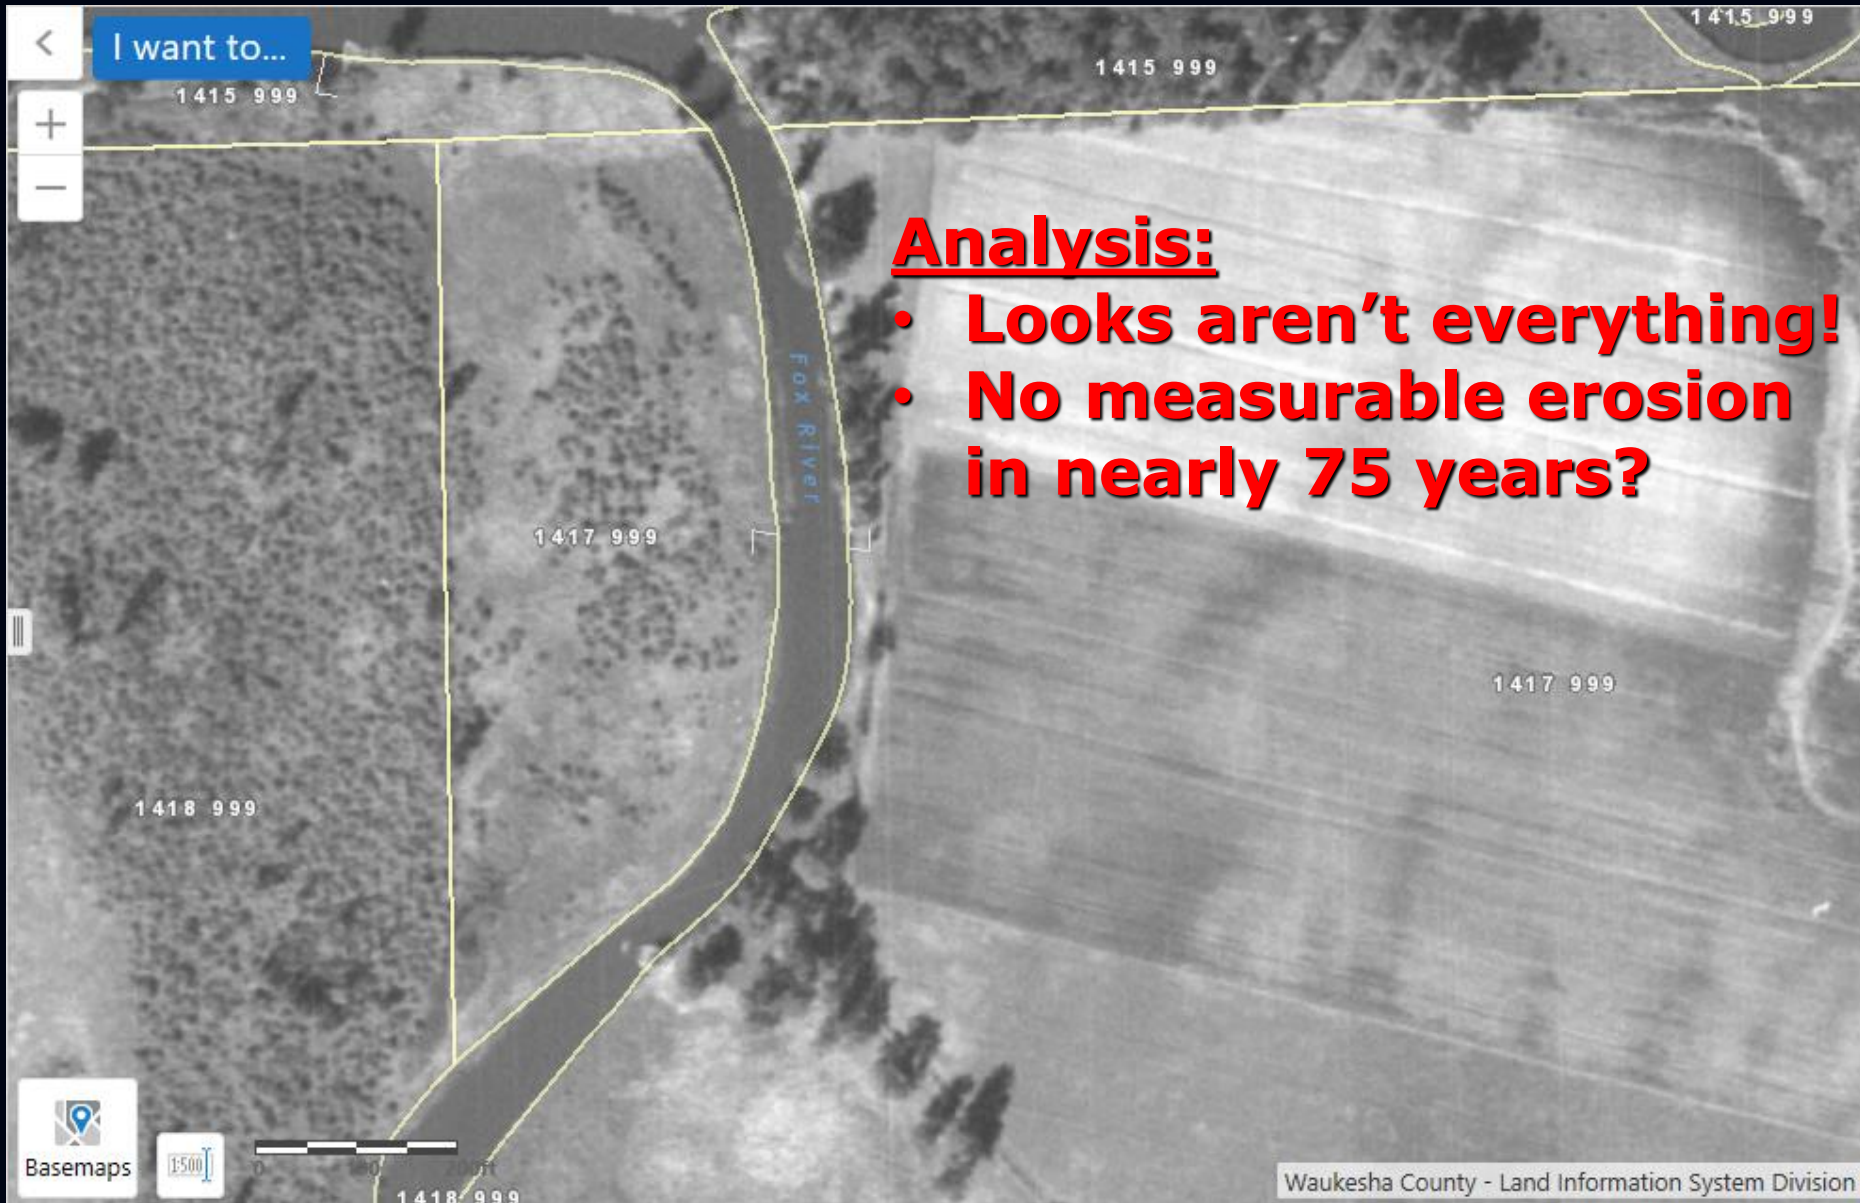
Streambank Erosion Site- 1941

- Looks aren't everything!
- No measurable erosion in nearly 75 years?
